# MIDWEST FLOODS of 2008 & IN IOWA & WISCONSIN

## 3 Residential, Historic, and Commercial Buildings

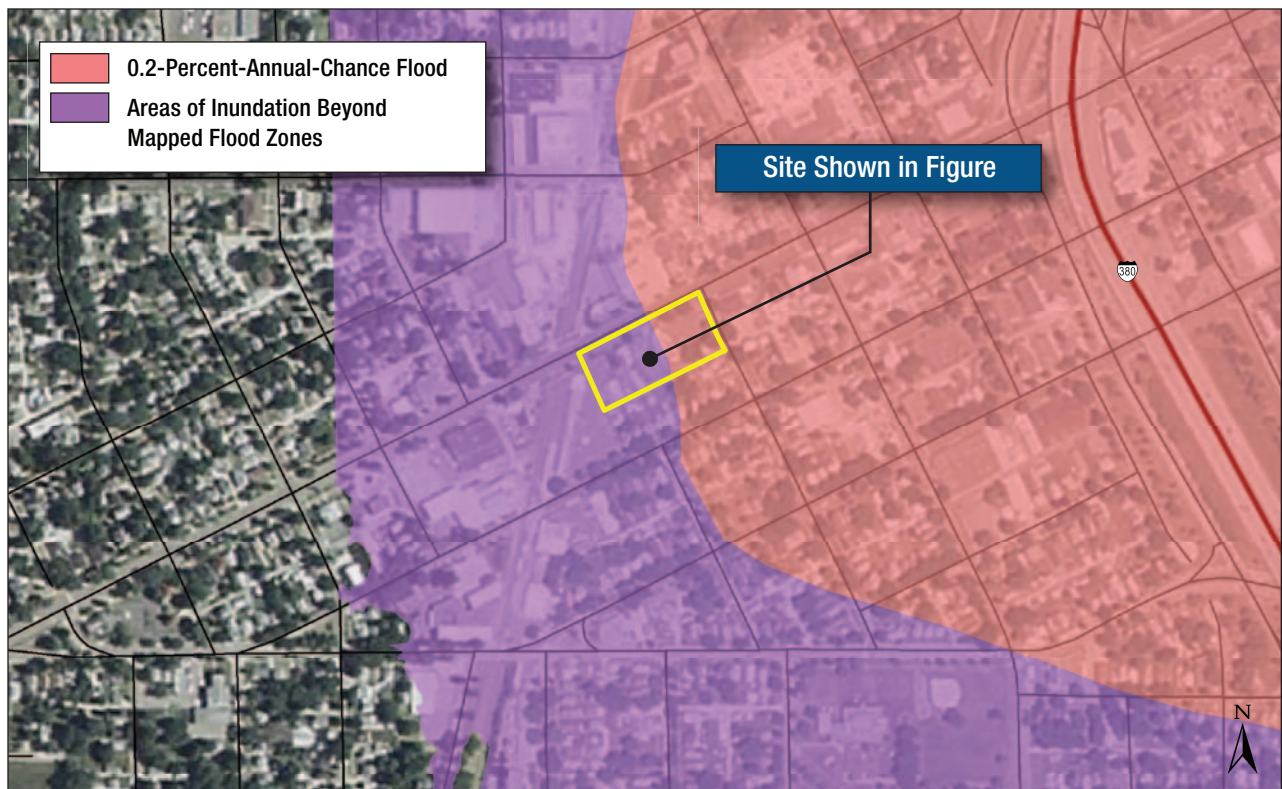
Figure 3-2 shows two buildings at the outer edge of the 0.2-percent-annual-chance flood zone (see also Figure 3-3). The waters were 4 feet above the first floor elevation at this location. This example highlights the residual risk and possibility of unexpected damage anywhere adjacent to even the 0.2-percent-annual-chance floodplain.

Figure 3-3.  
Location of commercial buildings shown above at the outer edge of the 0.2-percent-annual-chance flood zone (Cedar Rapids, Iowa).

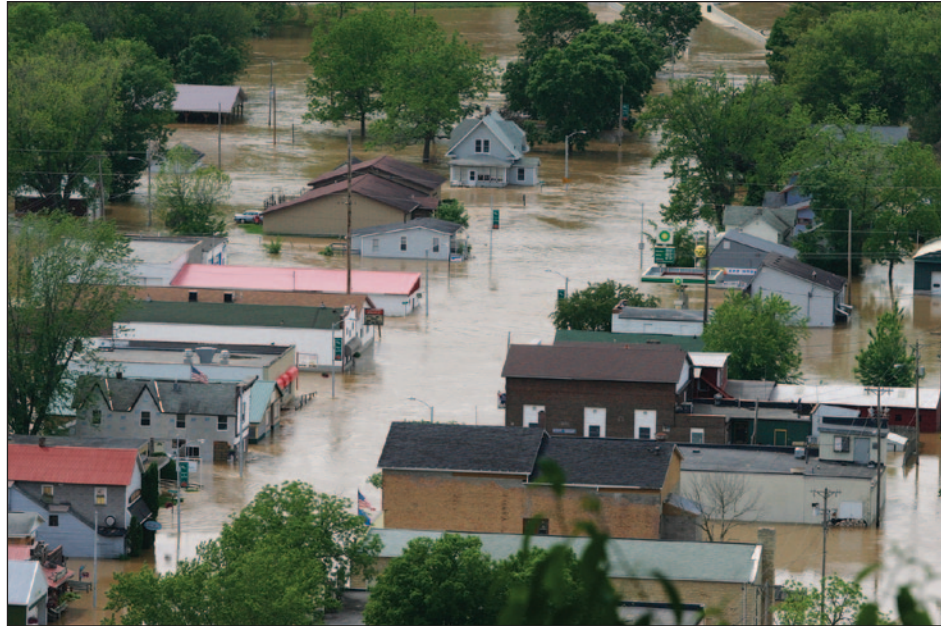
**Figure 3-4.**  
Inundation in Gays Mills, Wisconsin, where most of the town including all of Main Street is located in the SFHA. Most buildings along Main Street experienced 3 to 5 feet of flooding.

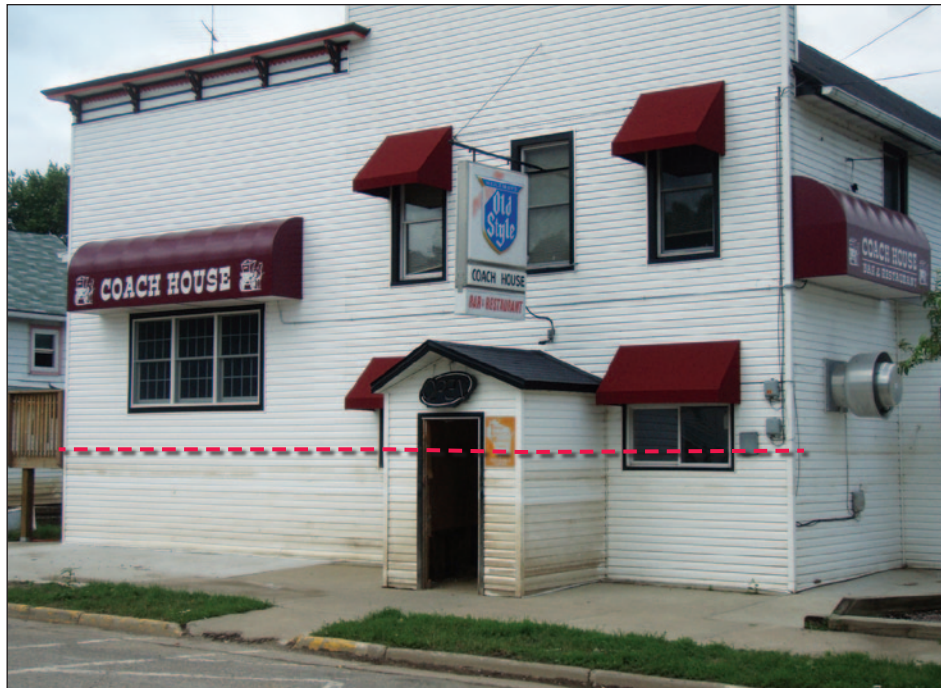
**Figure 3-5.**  
Commercial and residential buildings in Rock Springs, Wisconsin, along the Baraboo River where the flood was estimated to be a 0.2-percent-annual-chance flood were inundated with over 4 feet of water (dashed red line indicates the water line).

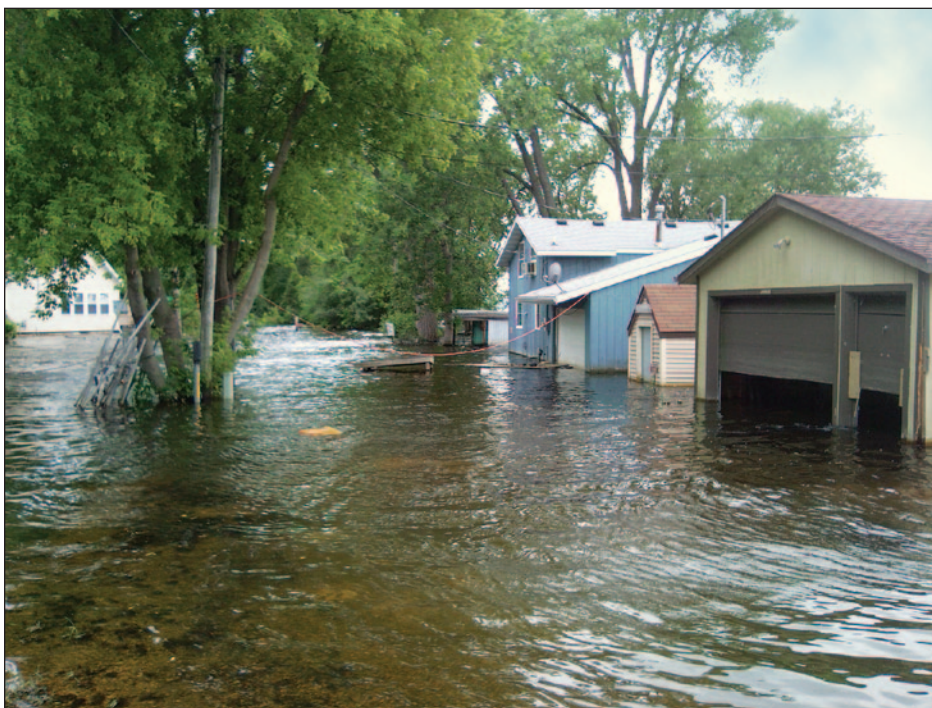
**Figure 3-7.** Buildings located within the SFHA along the Rock River in Rock County, Wisconsin, where the flood is estimated to have exceeded the 1-percent-annual-chance flood, experienced 2 to 4 feet of flooding.

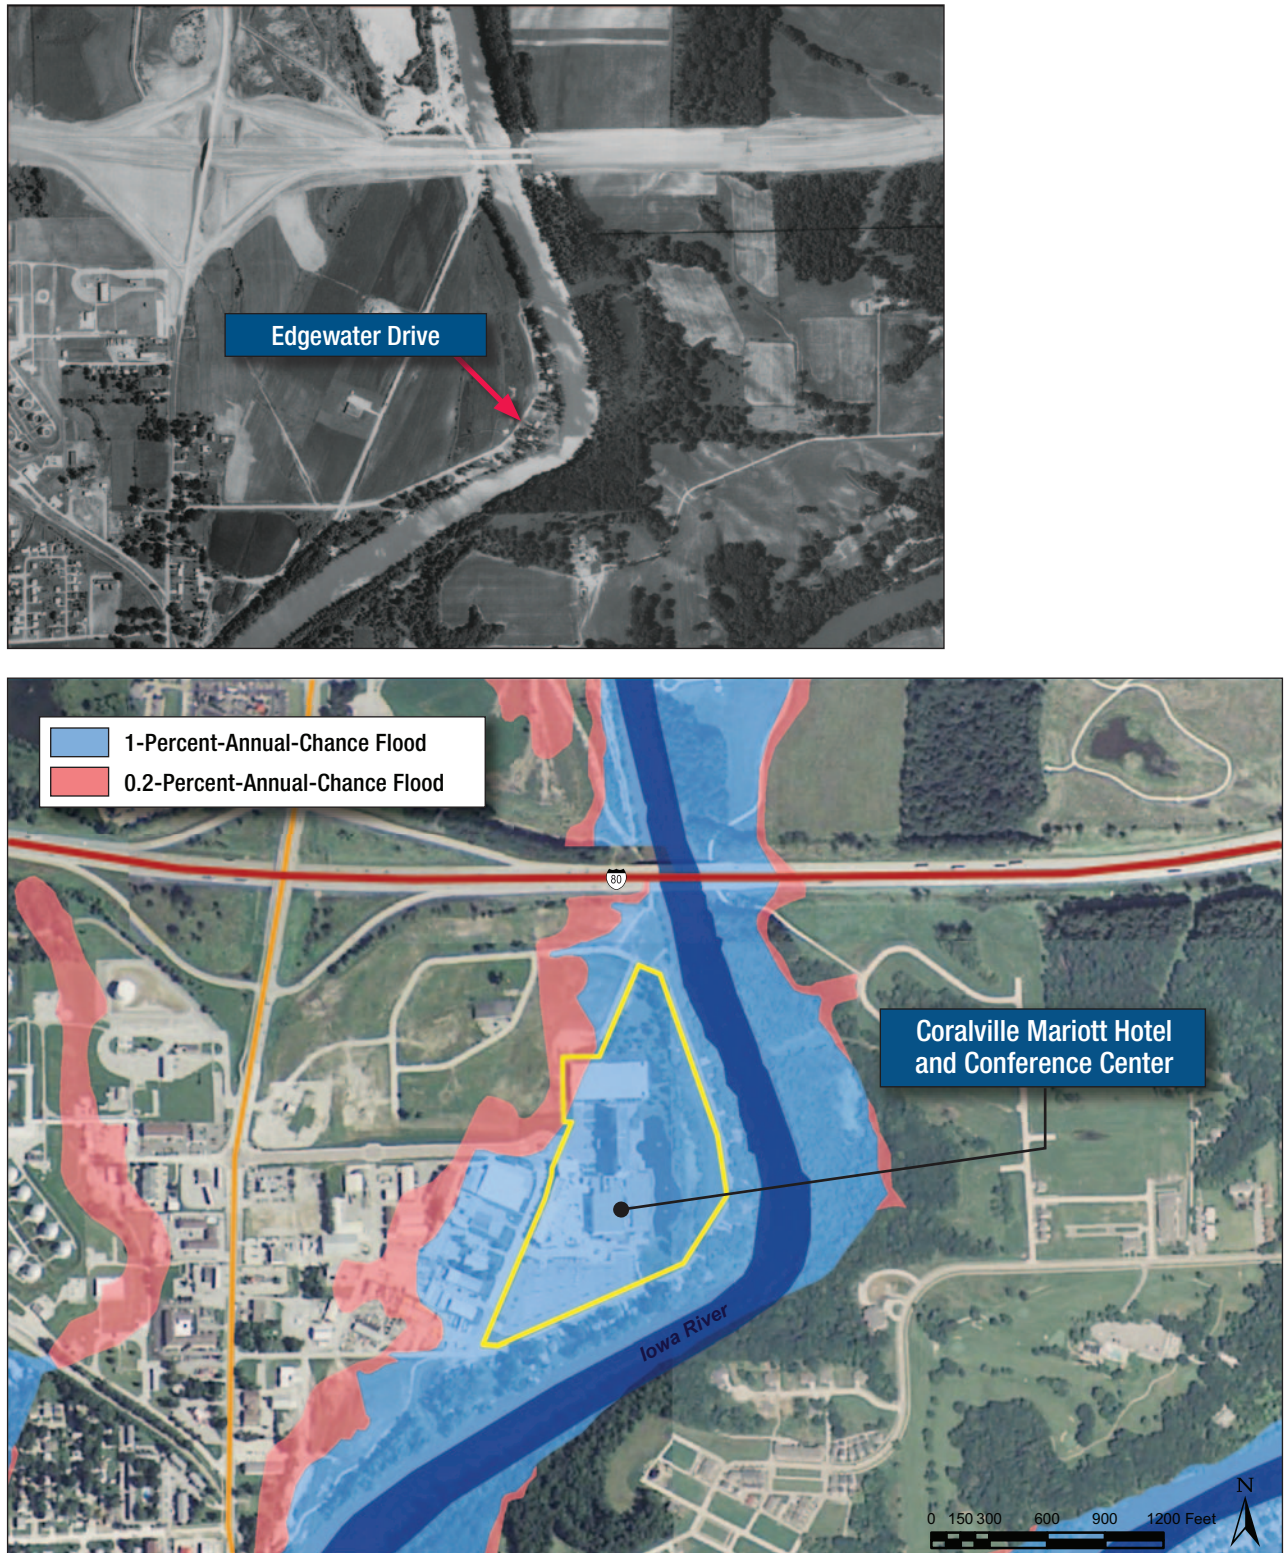
Figure 3-9.

The Coralville Conference Center is located on the former site of Edgewater Park and in the SFHA, 3 feet above the BFE. The two aerials reflect the development along Edgewater Drive over the past four decades (Coralville, Iowa).

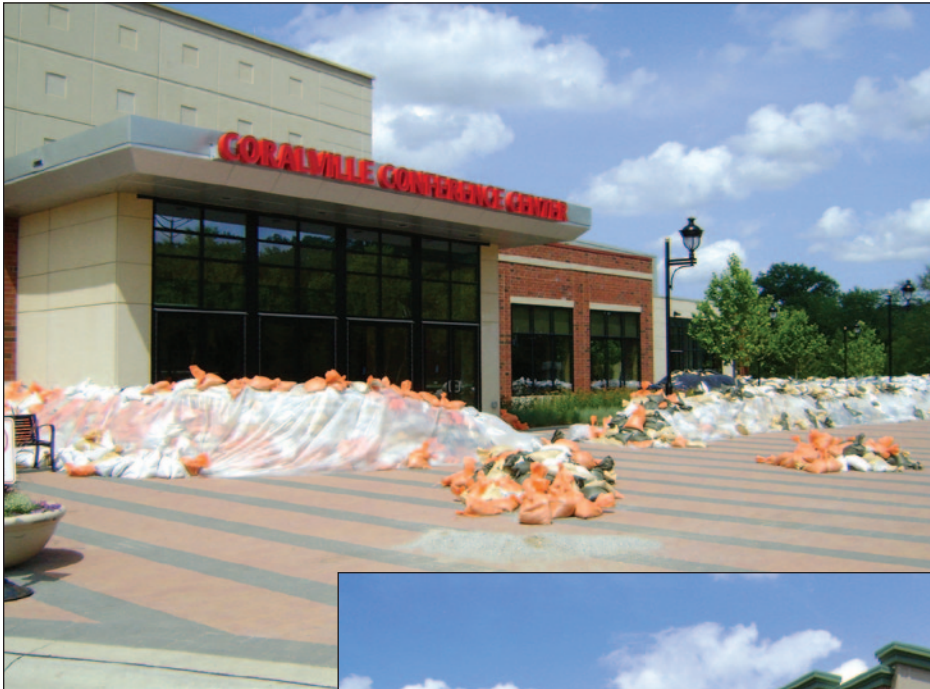
**Figure 3-10.**  
Although the Conference Center suffered minor damage, the adjacent buildings had extensive interior damage on the first floor (Coralville, Iowa).

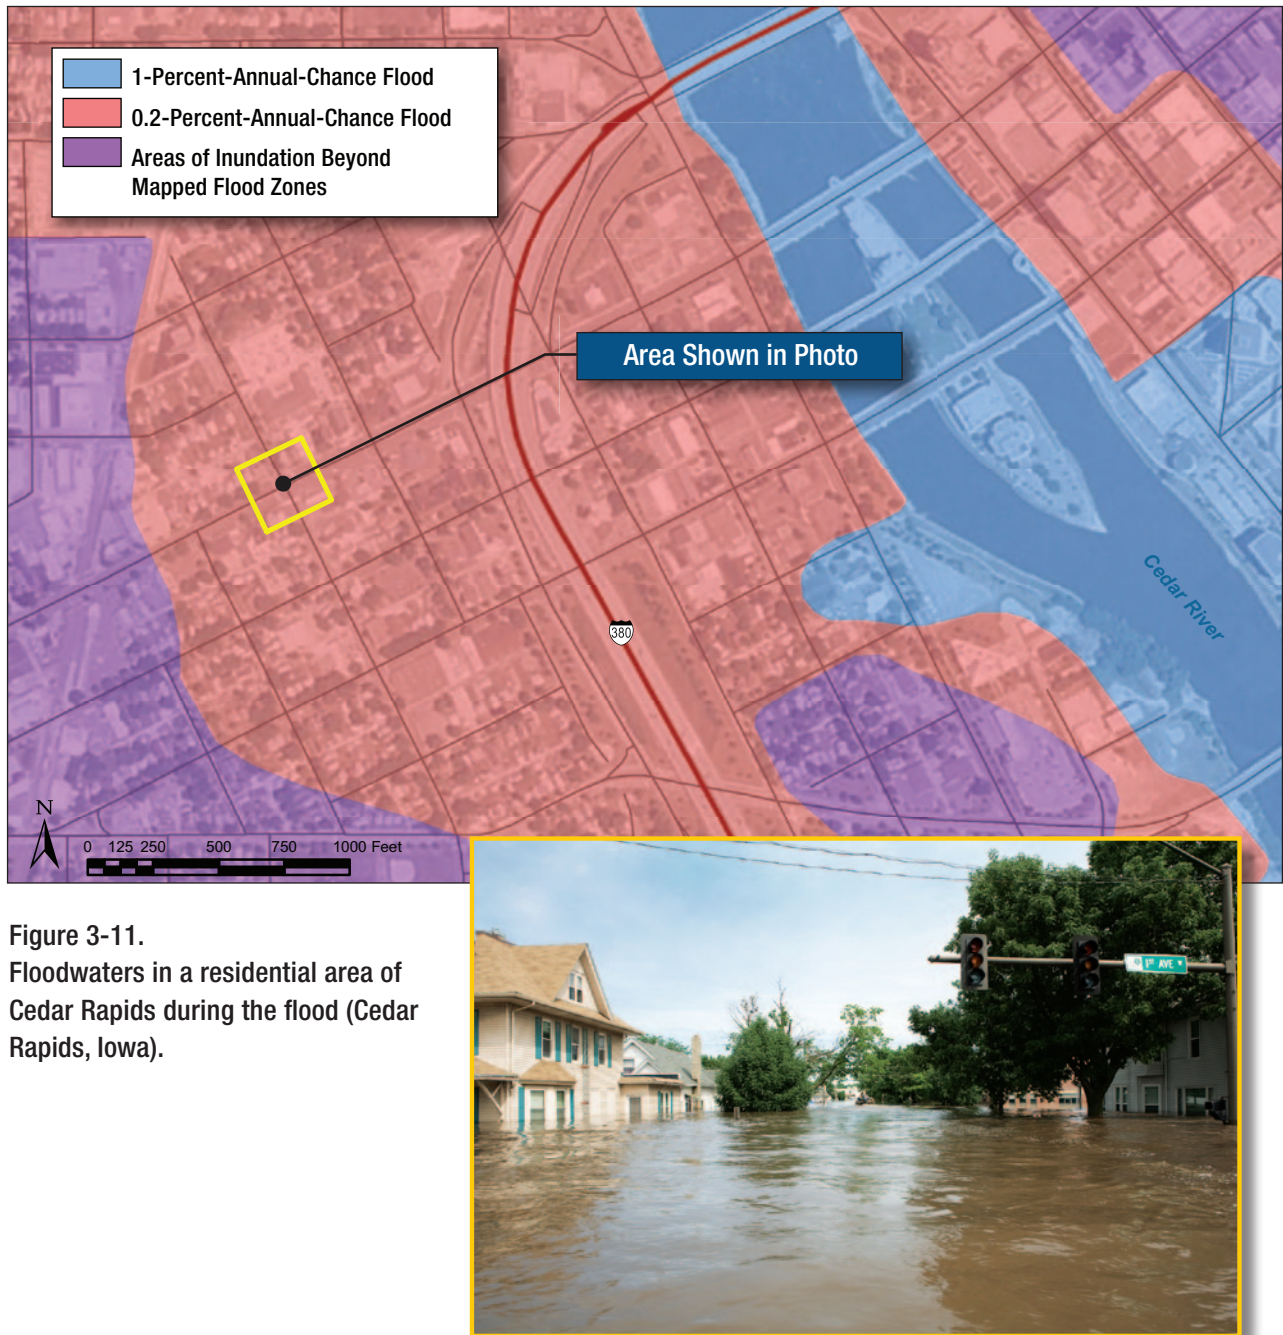
As previously noted in this report, residential structures were subject to a greater than design level of flooding in several communities visited by the MAT. Figure 3-11 shows a Cedar Rapids residential neighborhood in the 0.2-percent-annual-chance floodplain that had several feet of inundation. Flooding in Iowa and Wisconsin caused both velocity-flow and inundation damage; however, most of the damage was due to slow rising inundation. Due to high levels of soil saturation, these floodwaters also remained for weeks in some areas, much longer than typical flood events. The duration impacted recovery operations and hindered owners from returning to their properties to limit mold growth and further damages to their facility. The areas impacted by high-velocity flow were near floodways, at overtopped/breached levees, or near areas of flood flow constriction. The MAT surveyed single and multi-family residences, including some that were under repair at the time of

**Figure 3-11.**  
Floodwaters in a residential area of  
Cedar Rapids during the flood (Cedar  
Rapids, Iowa).

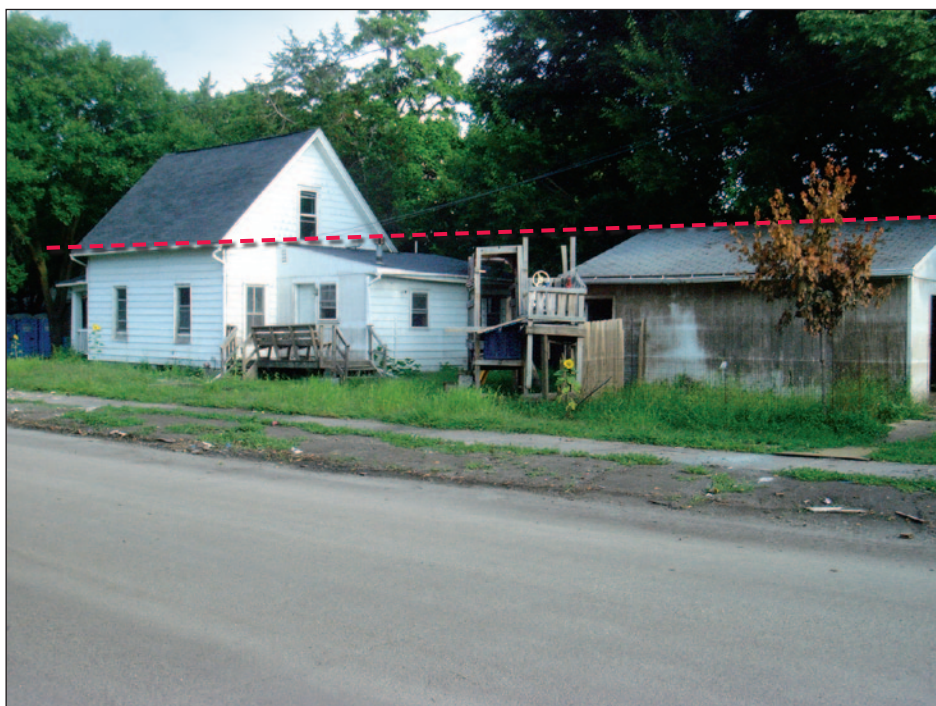
Figure 3-14.  
Pre-FIRM house located in the SFHA at N Avenue NW. Floodwater reached the eaves of these houses located a few blocks from a levee (red line indicates flood level) (Cedar Rapids, Iowa).

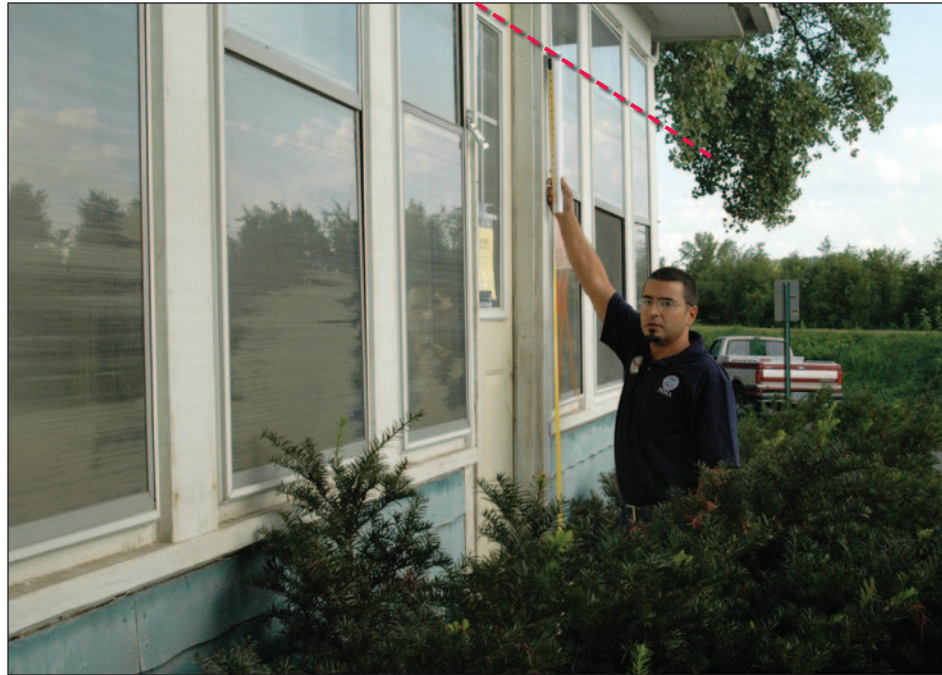
**Figure 3-15.**  
Pre-FIRM home at N  
Avenue NW located in the  
SFHA. Water marks near  
top of door and window  
frame. Marks are several  
feet above the levee seen  
in the background (Cedar  
Rapids, Iowa).

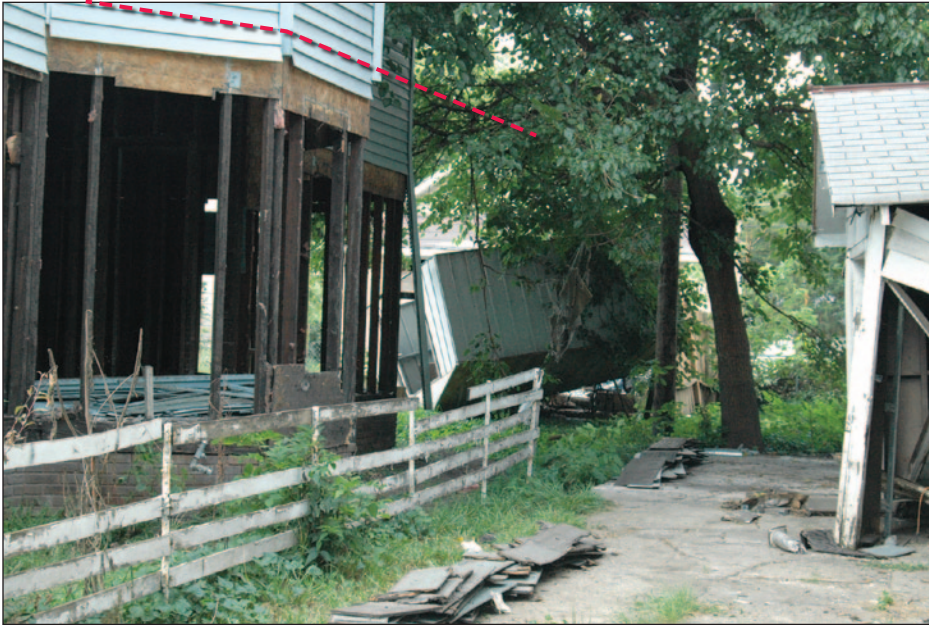
Figure 3-17.

This is another view of the house in Figure 3-16. The side wall and the adjacent structures are displaced in a way that suggests high-velocity water flows through this neighborhood (Cedar Rapids, Iowa).

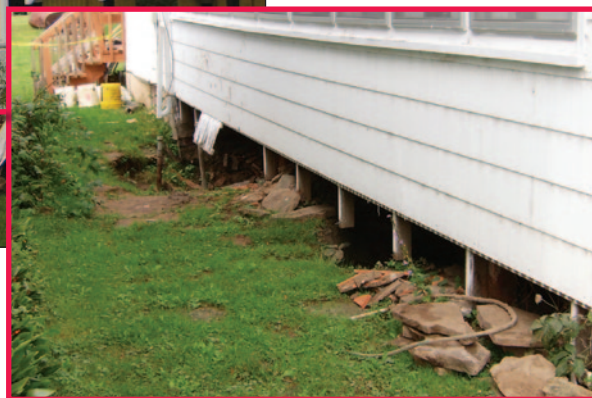
**Figure 3-23.**  
This foundation wall collapsed due to hydrostatic pressure (Reedsburg, Wisconsin).

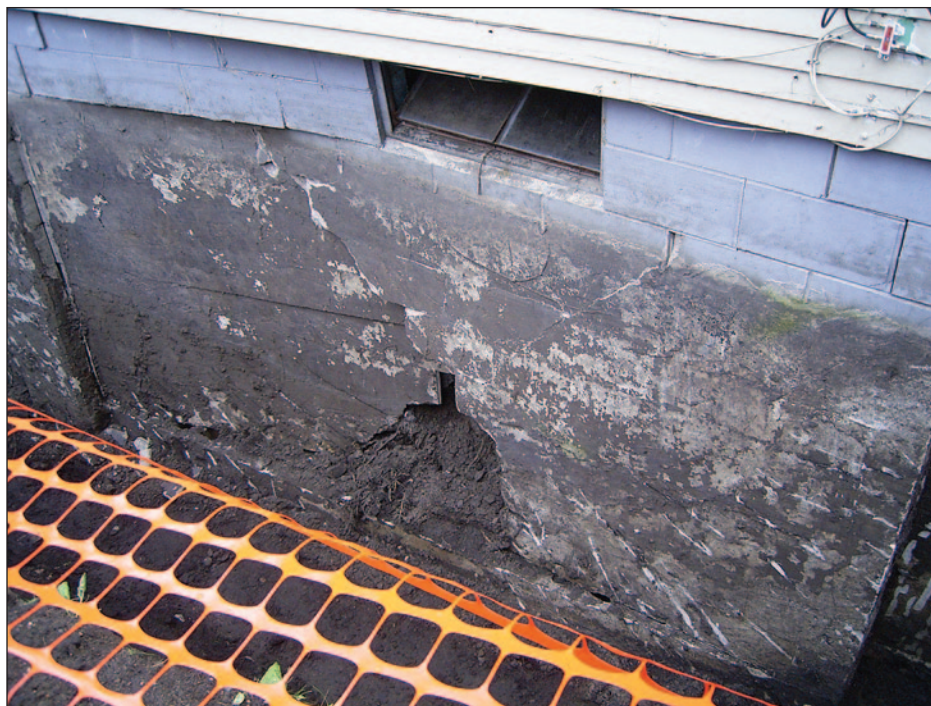
The most common form of structural damage to residential buildings observed by the MAT was the failure of foundation walls, especially those constructed of unreinforced masonry, as a result of lateral pressures from saturated soils and hydrostatic pressure, as illustrated in Figures 3-21 to 3-27.

Figure 3-25.  
This house had two walls that were damaged due to hydrostatic pressure (Reedsburg, Wisconsin).

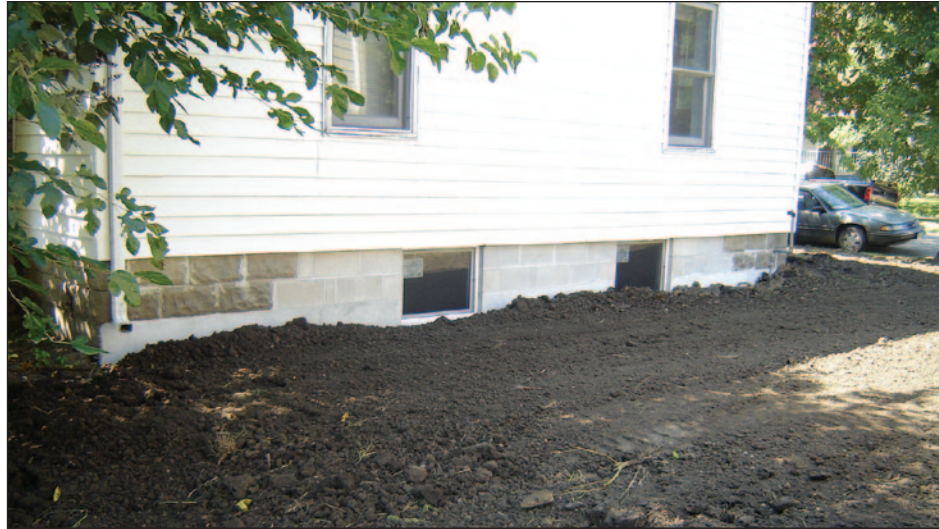
Figure 3-26.

Example of a completed foundation wall repair that included vertical steel reinforcement and grout throughout the repaired wall to improve the strength and performance of the foundation (Waverly, Iowa).

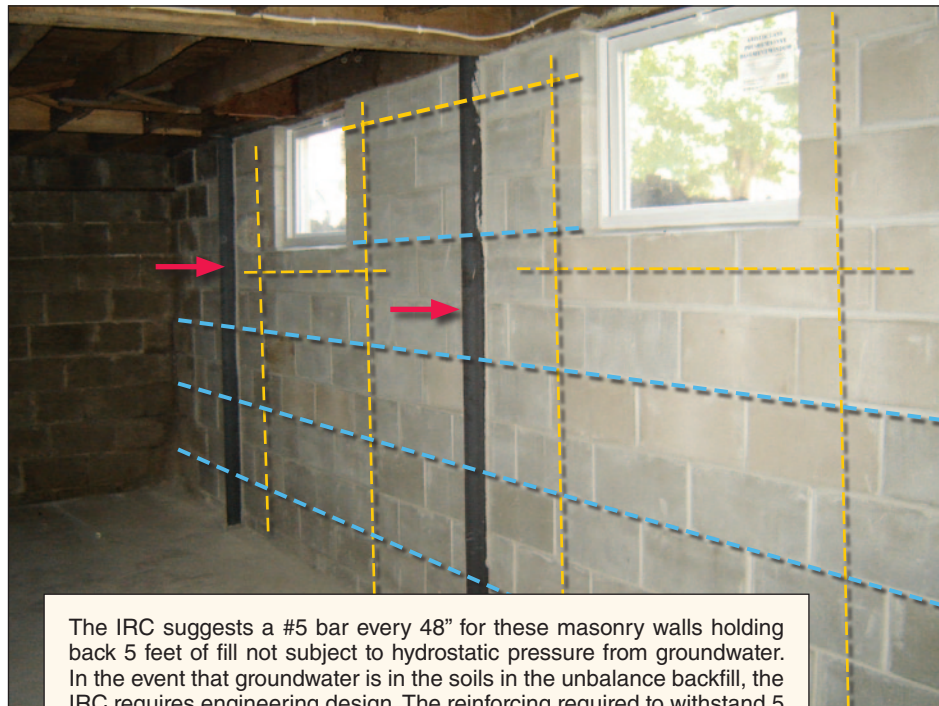
Figure 3-27.

Interior view of the completed foundation wall repair in Figure 3-26; the owner stated that they placed horizontal steel reinforcement where possible along the top row of masonry blocks to create a bond beam. The yellow and blue lines are suggested reinforcing locations. This wall shows an alternative of external reinforcing of the wall using steel angles (red arrows) (Waverly, Iowa).

The IRC suggests a #5 bar every 48" for these masonry walls holding back 5 feet of fill not subject to hydrostatic pressure from groundwater. In the event that groundwater is in the soils in the unbalance backfill, the IRC requires engineering design. The reinforcing required to withstand 5 feet of water-laden soils is approximately a #5 bar every 16", or one per block, three times the number shown. Bond beams are recommended at all opening perimeters as well as at the top and bottom of the wall. Horizontal joint reinforcing should also be used every 16" vertically (blue dashes in Figure 3-27).

It is important to remember that repairing and reinforcing only the failed portions of a basement will not completely address weaknesses in the structure, and the basement will remain vulnerable to failure during future floods. In most homes with basements, all basement walls are constructed similarly and have similar strengths (see text box). When walls are similarly constructed, the relative performance of individual walls becomes a function of the loads applied to them and not of their strengths. Walls fail not because they are greatly weaker than adjacent walls but because

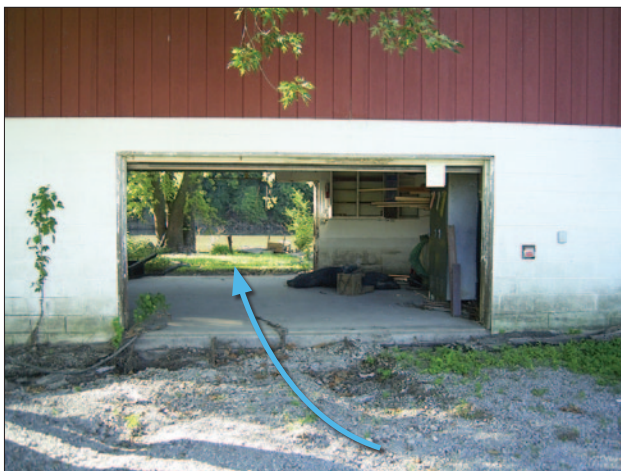
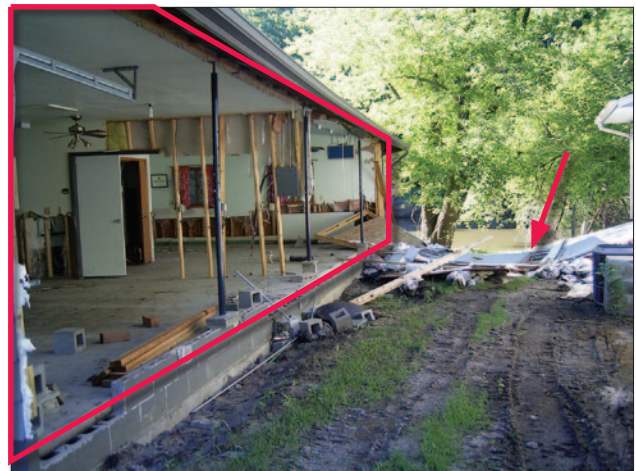
**Figure 3-28.**

Most structures visited by the MAT were impacted by water velocities that were slow enough that the buildings showed signs of inundation but not movement; however, there were occasional incidences of high-velocity flow that moved structures off their foundations. Buildings near breached or overtopped levees were most susceptible to high-velocity floodwaters that caused scour, carried large flood-borne debris, and imposed hydrodynamic forces that impacted the structural integrity of the building. In some areas, major structural damage resulted to both the foundation and the superstructure. Some structures were displaced from their foundations and driven into nearby spaces, roads, and the river. Figure 3-28 shows a house impacted by high-velocity floodwater.

The house on the left experienced high-velocity flow that passed through the lower level of the structure. The house on the right had living space at the same elevation, and the rear of the house was displaced. The red outline is the original location of the wall; the red arrow points to the location of the wall after the flood. This area experienced flooding that exceeded the estimated 0.2-percent-annual-chance flood (Coralville, Iowa).

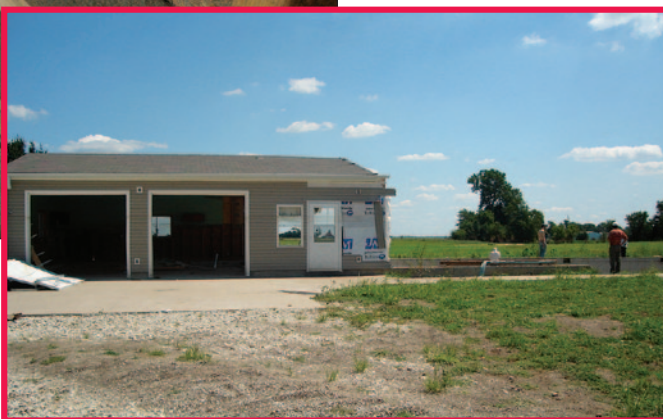
Figure 3-35. The framing for the portion of the home that remained in place was bolted down to the foundation (this is the same manufactured home referenced in Figure 3-31 through 3-34) (Oakville, Iowa).

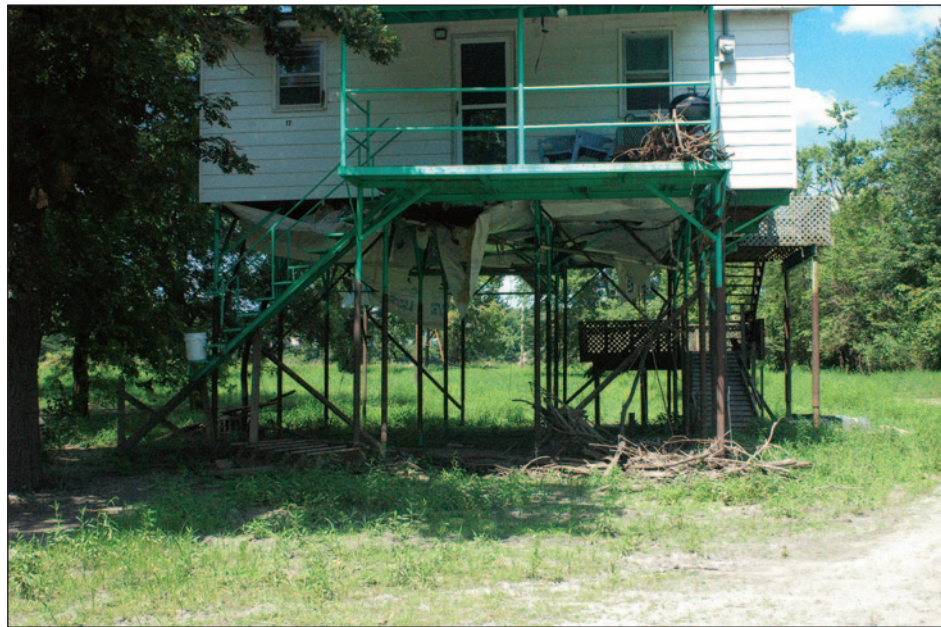
**Figure 3-37.**  
Residential building constructed on open foundation that suffered considerably less damage than those on closed foundations in the same area. Slender columns such as those shown here offer little resistance to lateral loads that can occur from flooding and debris. Accounting for gravity and lateral loads, not just elevation, should be considered during design (Oakville, Iowa).

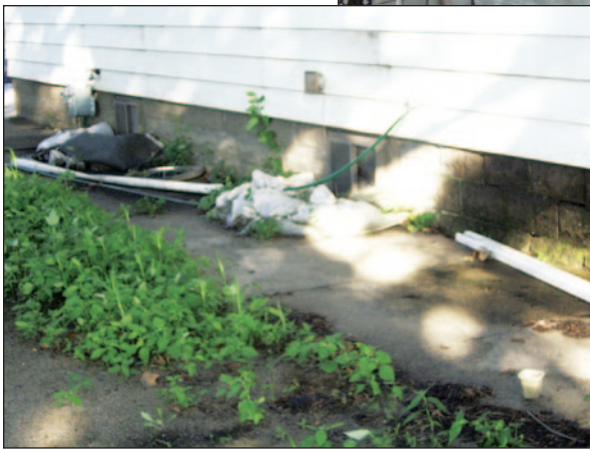
**Figure 3-40.**  
This basement sustained damage to the mechanical and plumbing systems of the home (Waverly, Iowa).

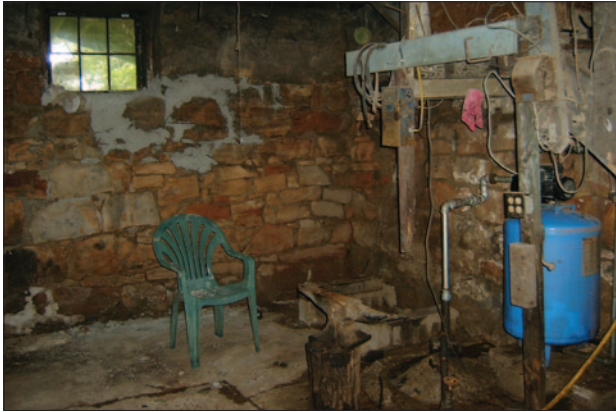
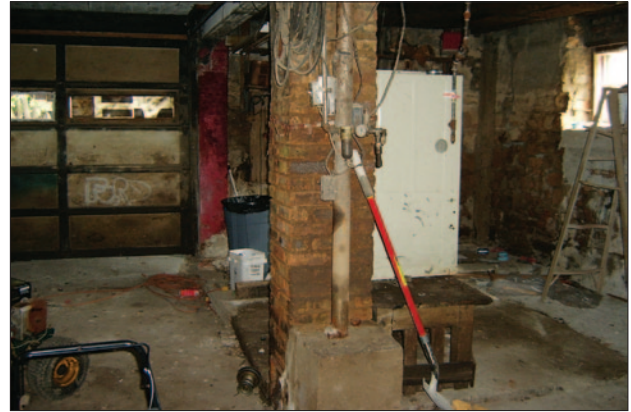
**Figure 3-41.**

Basement located in a circa 1880s house. This basement has a furnace and other utilities that were inundated with 6 to 8 feet of standing water (Rock Springs, Wisconsin).

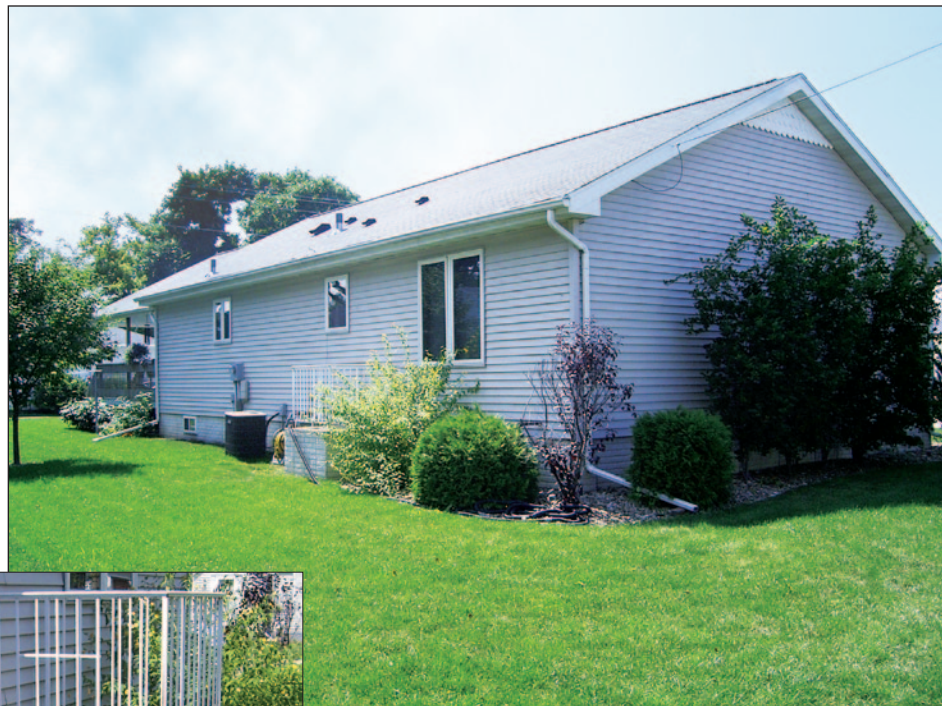
**Figure 3-43.**  
Post-FIRM construction with a basement in a community approved for residential basement floodproofing. The basement performed as designed with a pump removing all flood and groundwater that entered (La Porte City, Iowa).

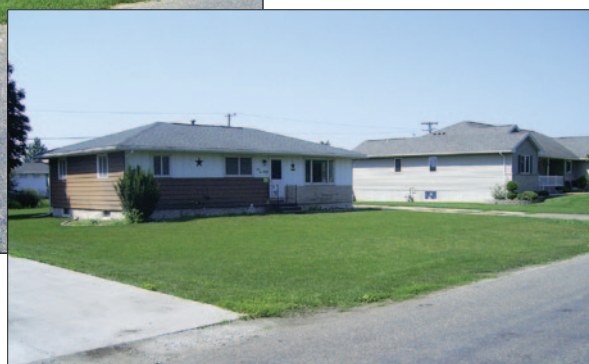
Damage in one newly engineered basement was reported by a homeowner where floodwater exceeded the floodproofing design elevation. These damages were in a basement just outside the SFHA (see Figure 3-44).

Figure 3-44.  
This house located just outside the SFHA suffered no damage on the first floor (unlike the adjacent property), but the basement suffered damages to architectural finishes, electrical systems, and contents (Palo, Iowa).

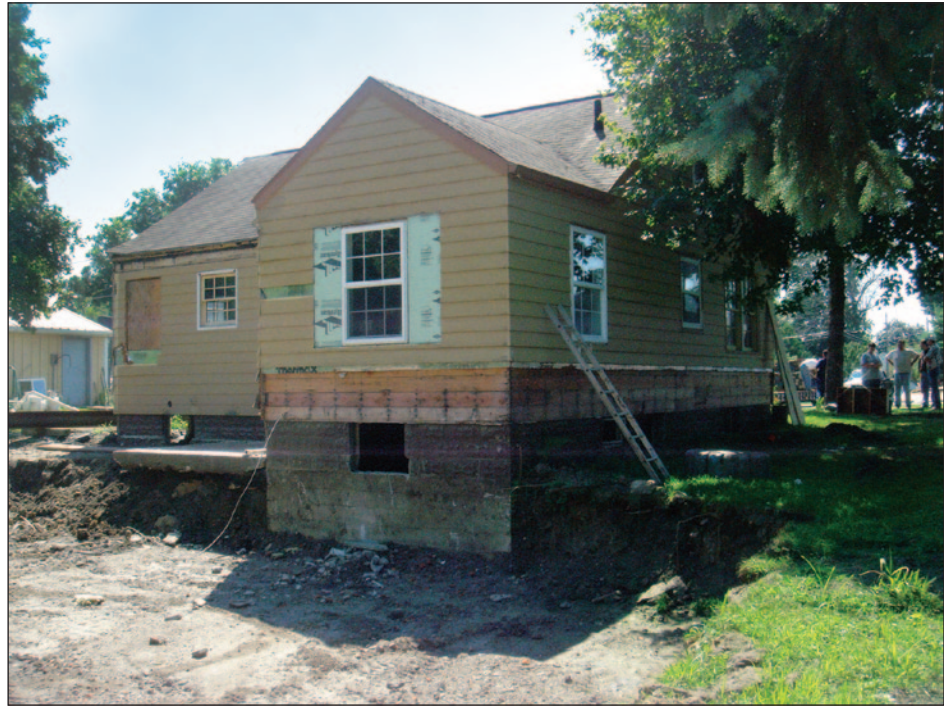
It is important for communities to ensure basements are removed (unless properly approved) when substantially damaged properties are being elevated or reconstructed in the SFHA. Figures 3-45 and 3-46 are examples of completed and ongoing elevation projects where basements were kept in the SFHA.

Figure 3-46.  
Ongoing elevation of  
property located in  
the floodplain where  
homeowner was planning  
to keep the basement  
(Vinton, Iowa).

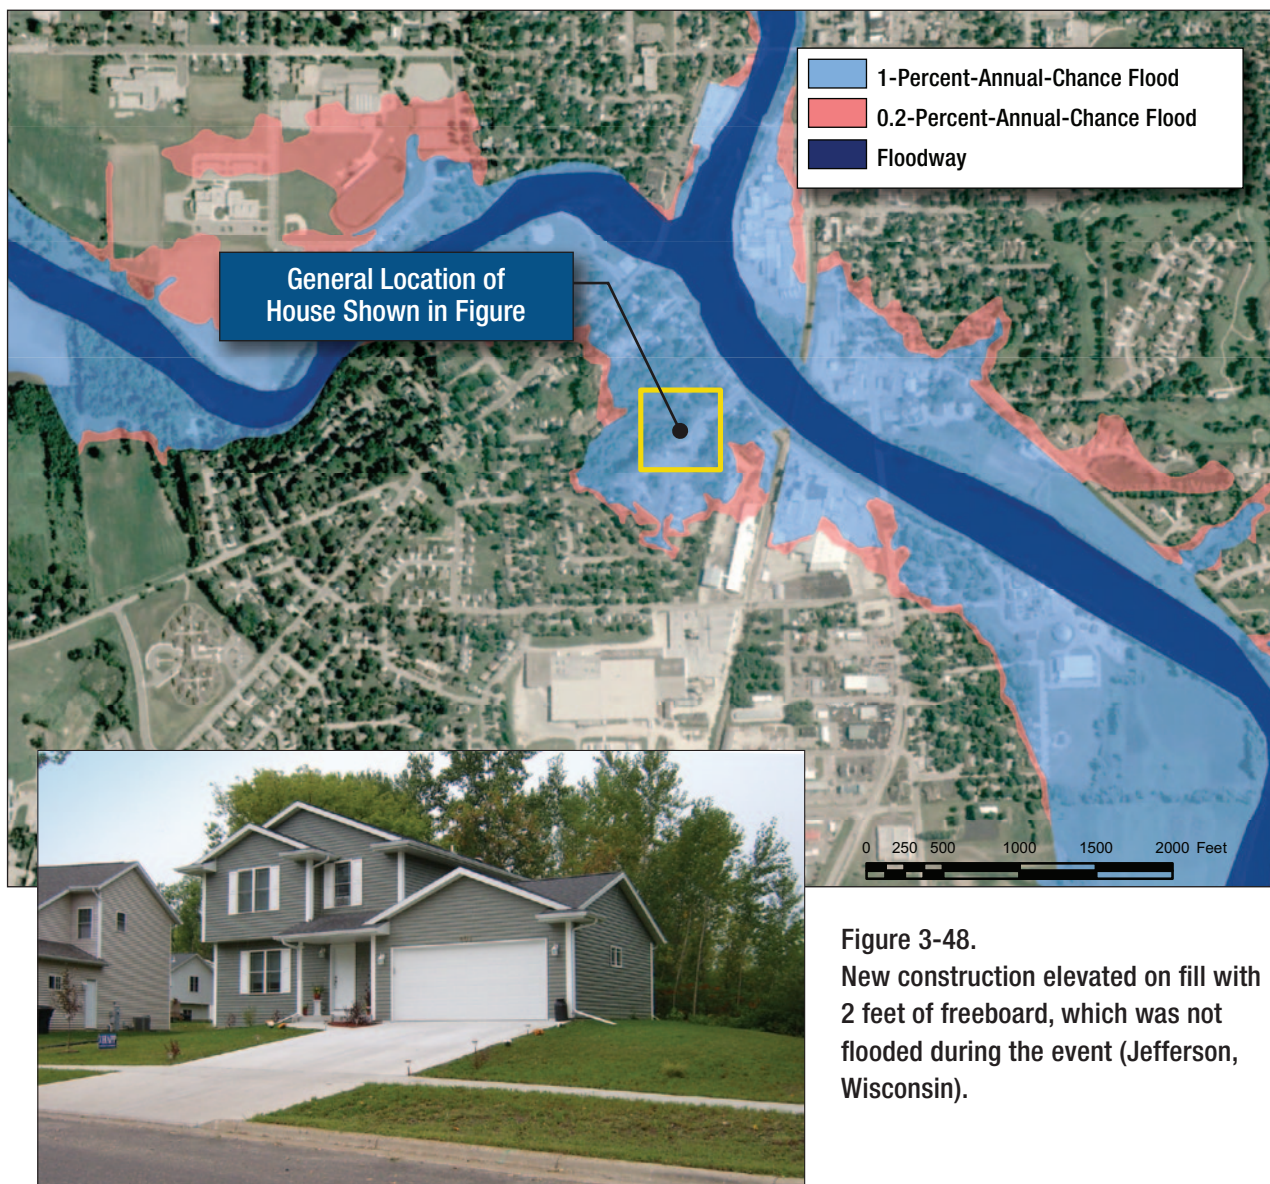
**Figure 3-48.**  
New construction elevated on fill with 2 feet of freeboard, which was not flooded during the event (Jefferson, Wisconsin).

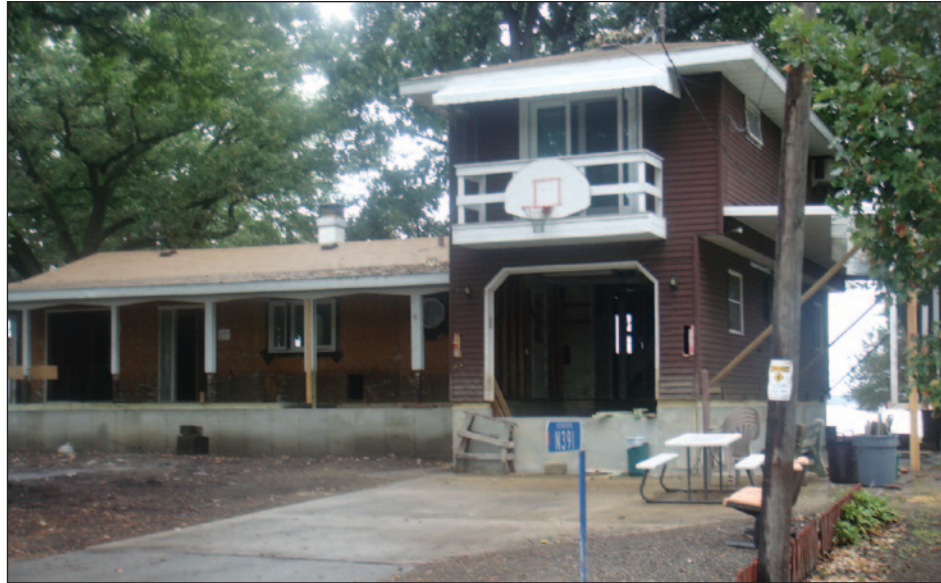
**Figure 3-49.**  
Existing house being  
elevated 2 feet above  
the BFE (Koshkonong,  
Wisconsin).

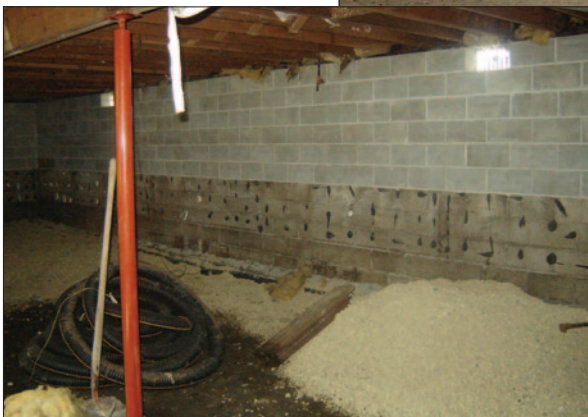
The MAT observed several elevated buildings in the SFHA without openings in their foundation walls that met the NFIP regulations. Several buildings did not have any openings while others either did not have enough or they were not at the proper elevation. The openings on the newly elevated house shown in Figure 3-50 are not within one foot of either interior or exterior grade as required.

**Figure 3-50.**  
Recently completed  
elevation project, properly  
elevated above BFE;  
however, the foundation  
does not have openings  
at the proper height  
(red circles). The crawl  
space floor is at the same  
elevation as the exterior  
grade (New Hartford, Iowa).

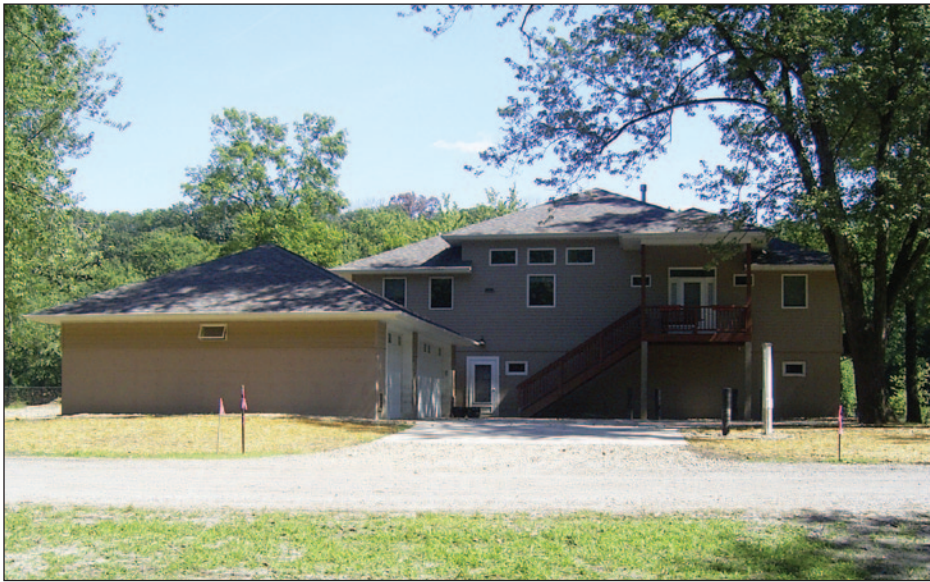
Figure 3-51.

This property, which was constructed not long before the Midwest floods, is elevated several feet above BFE and was the least damaged along a row of more than 50 riverfront properties (Iowa City, Iowa).

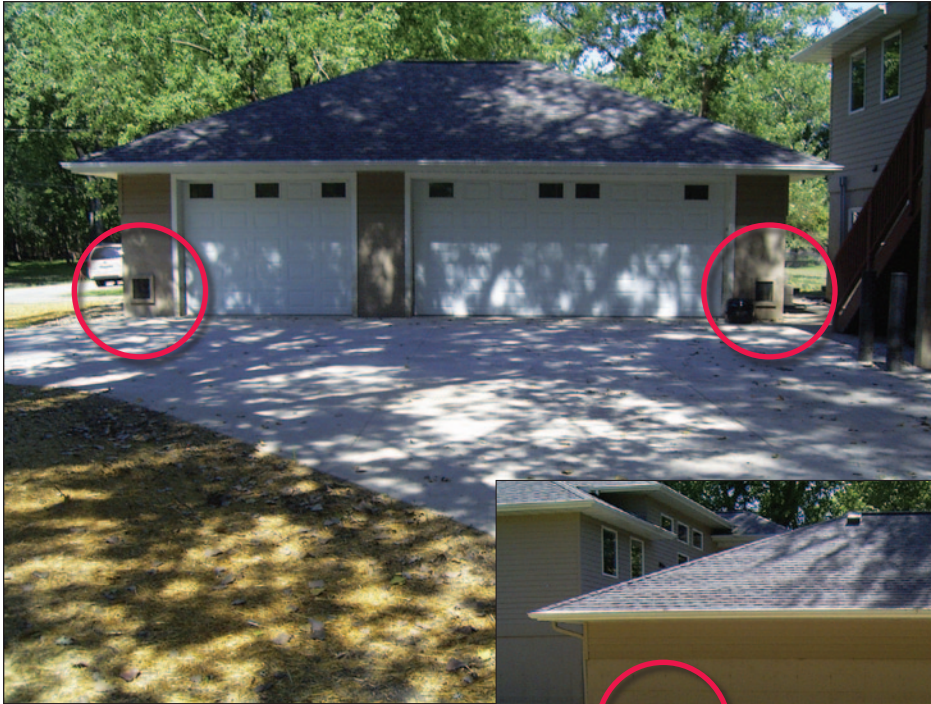
Figure 3-52.

The house in Figure 3-51 is located in River Front Estate Acres depicted above. The lots are located on the river's edge in the SFHA (Iowa City, Iowa).

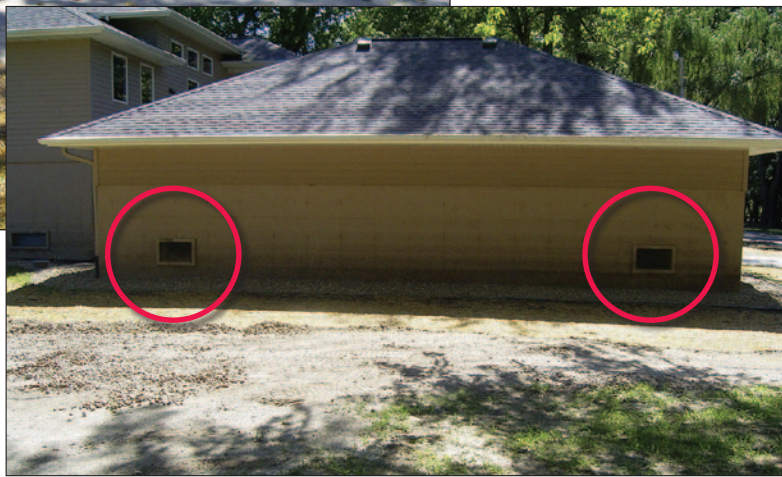
**Figure 3-53.**  
This riverfront house's two-car garage was one of only a few properties throughout the areas visited by the MAT with proper flood vent openings (Iowa City, Iowa).

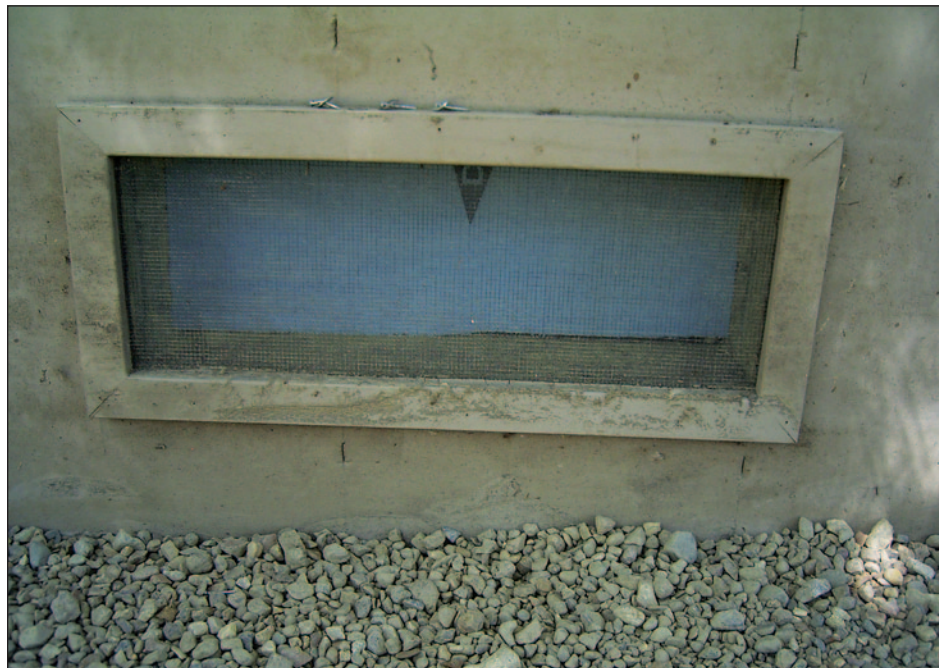
**Figure 3-54.**  
Unlike the garage, the riverfront house's flood openings were obstructed (Iowa City, Iowa).

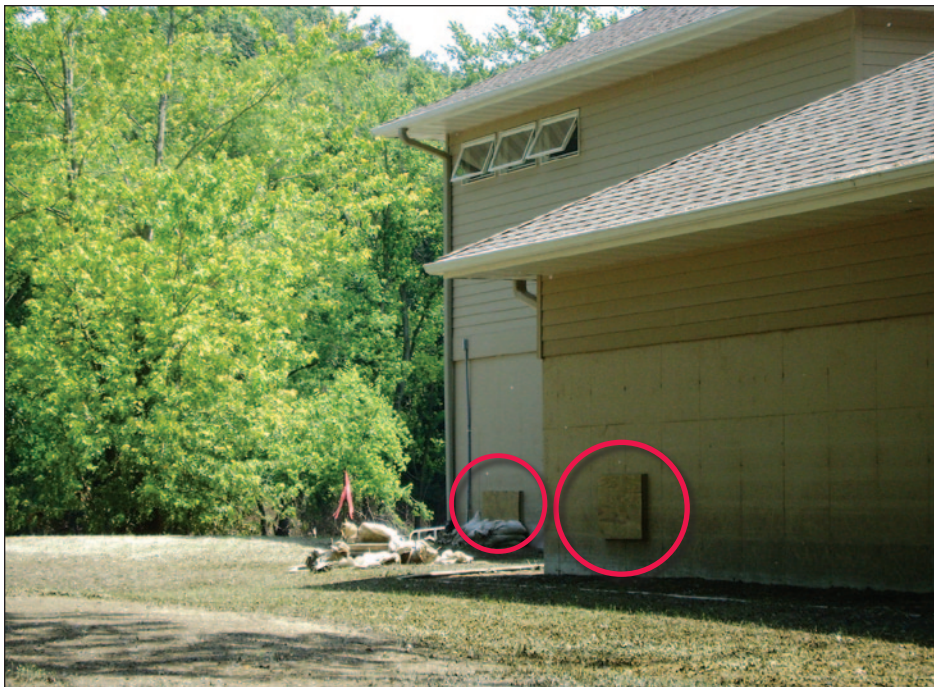
**Figure 3-55.**  
The homeowner had covered the openings on both the house and garage during the flood (Iowa City, Iowa).
